Resurrecting Dirty AFM Calibration Standards

Abstract

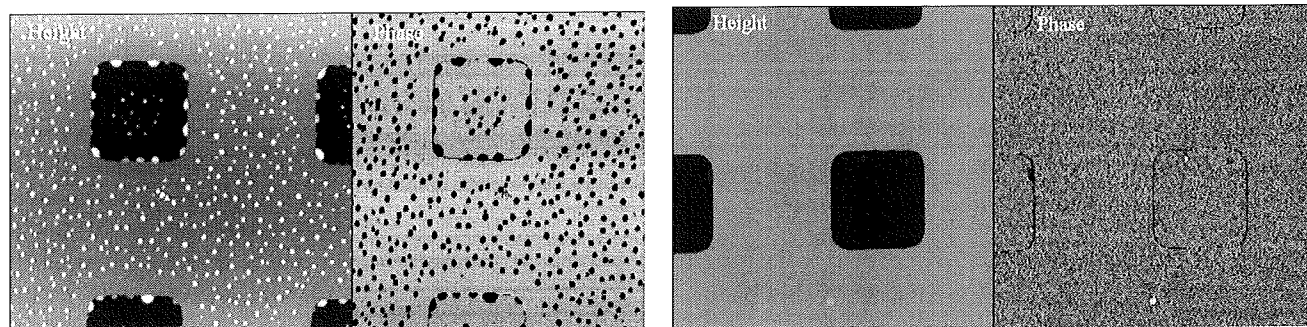
Figure 1. Height and Phase image of the contaminated surface of an 18 nm step grid. 15 μm scan. Figure 2. Height and Phase image, after cleaning. 15 μm scan.

Figure 1 shows a tapping height and phase image of a random 15 μm field of view within the patterned area of sample BK88-A, an 18 nm step grid. The height image (left) shows a large number of small bumps distributed across the surface. The phase image (right) shows that these bumps have low phase relative to the surrounding substrate. Under our operating conditions, low phase indicates low stiffness and/or high adhesion. Based on this, we suggest that the bumps are a soft, organic contaminant. Figure 2 was captured 3 weeks after CO₂ snow cleaning. It shows another random 15 μm field. It is clear that the contaminating particles were almost totally removed. This result was typical for almost all of the contaminated calibration specimens.

Now consider the particle sizes. Referring to the “before cleaning” image (fig.1), we selected a 5.9x5.9 μm² area of land between 4 pits and measured the bump heights of all particles in that region which were taller than 3 nm above the mean substrate elevation. The 3 nm threshold was chosen to exclude surface roughness and noise spikes. The height distribution (fig. 3) was bimodal with the large particle peak at about 27 nm and the small particle peak below 5 nm. The particle density was 3.5/μm². Fig. 4 shows a height profile crossing the lithographic step (measured here as 19.2 nm) and a particle almost twice as high (34.5 nm). Figure 5 shows a typical small particle was 4.8 nm high. After

cleaning (fig. 2), we found only 4 particles in the entire $15 \times 15 \mu\text{m}^2$ field of view. The particle density was $0.018/\mu\text{m}^2$, an apparent 99.5% reduction in overall particle density. All four particles were 4 to 5 nm high. Figure 6 shows a section plot across the step (measured here as 18.9 nm) and through one particle that was 4.6 nm high. For this sample, it appears that the treatment removed all particles taller than 5 nm and 96% of particles 3-5 nm high.

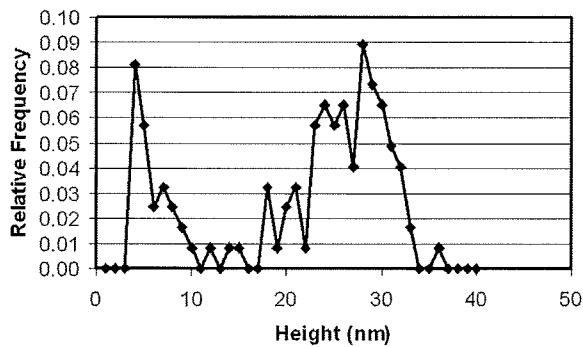
Figure 3. Histogram of bump heights on the 18 nm step grid before cleaning.

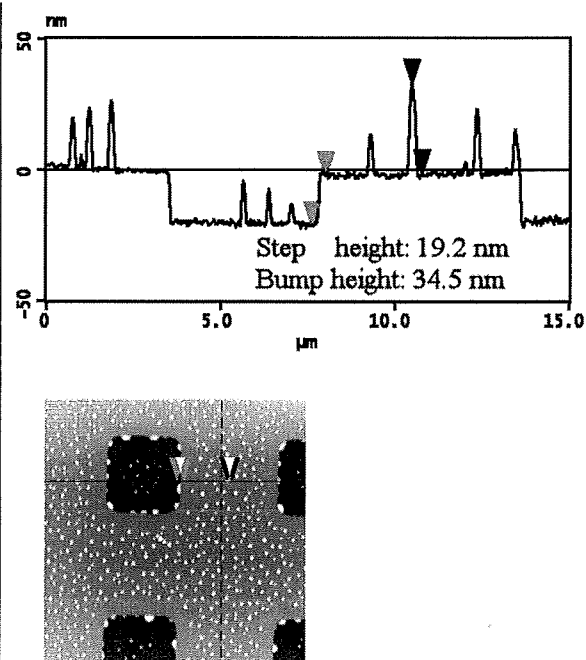
Figure 4. Height profile of the 18 nm step grid before cleaning, showing the measured step height (19.2 nm) and a typical tall particle almost twice as high (34.5 nm)

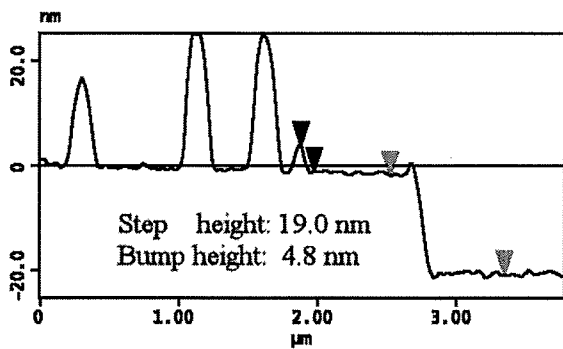
Figure 5. Another height profile before cleaning showing a typical small particle, 4.8 nm high.

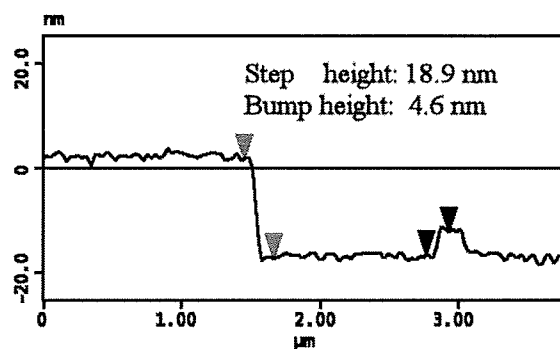
Figure 6. Height profile after cleaning showing a remaining particle, 4.6 nm high.

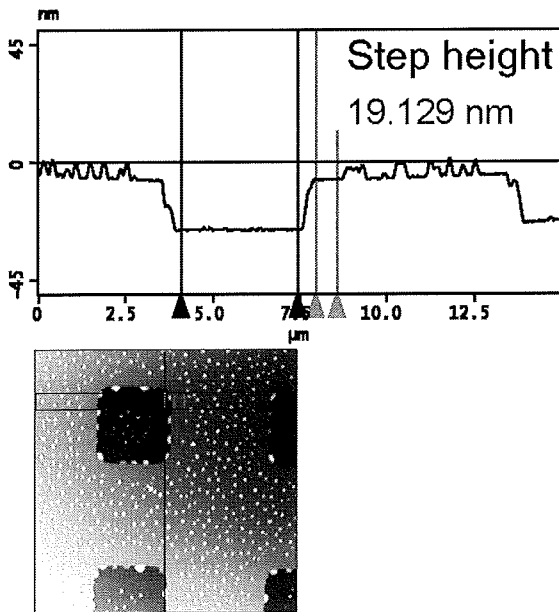
Figure 7. Step height measured before cleaning, using average lower and upper elevations in rectangular regions that were free of contaminant particles.

It is reasonable to ask whether the cleaning treatment has any adverse effects on step heights. To answer this, we first measured step heights in clean areas on the contaminated and cleaned samples. For sample BK88-A (18 nm step), we found a step height of 19.13 nm before cleaning (fig. 7) and 19.58 nm after cleaning (fig. 8), a difference of 0.45 nm (2.17%). For sample AZ57-3 (180 nm step), we found a step height of 178.16 nm before cleaning (average of 2 pits) and 180.22 nm after (average of 4 pits), a difference of 2.06 nm (1.16%). Because these measurements were made months apart, they are subject to an uncertainty of $\pm 2.5\%$. Although the before-after differences were less than this uncertainty, we decided to do a careful, same-day run of measurements to get a higher precision step height comparison. Using cleaned sample AZ57-3, we identified a specific pit and imaged the step height three times, withdrawing the probe and re-engaging between images. We then applied the CO2 snow cleaning treatment and measured the same pit again, with three separate measurement cycles, as before. The averages of three measurements before and after were 180.803 and 180.707 nm, respectively, a difference of 0.097 nm (0.05%). All of these results show that the cleaning process does not alter step height.

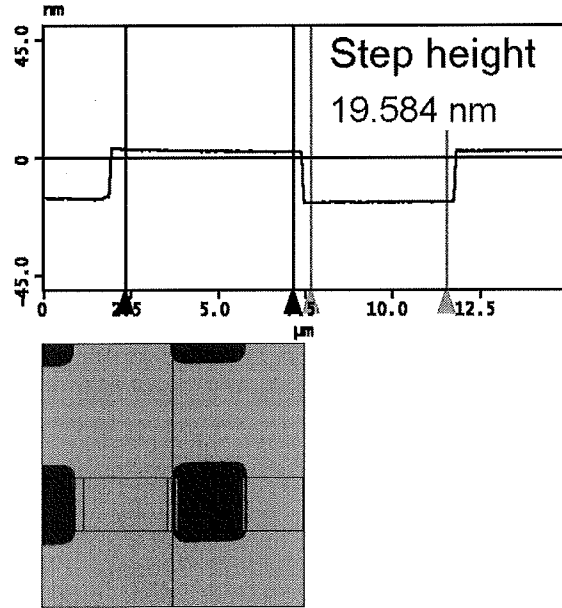
Figure 8. Step height after cleaning.

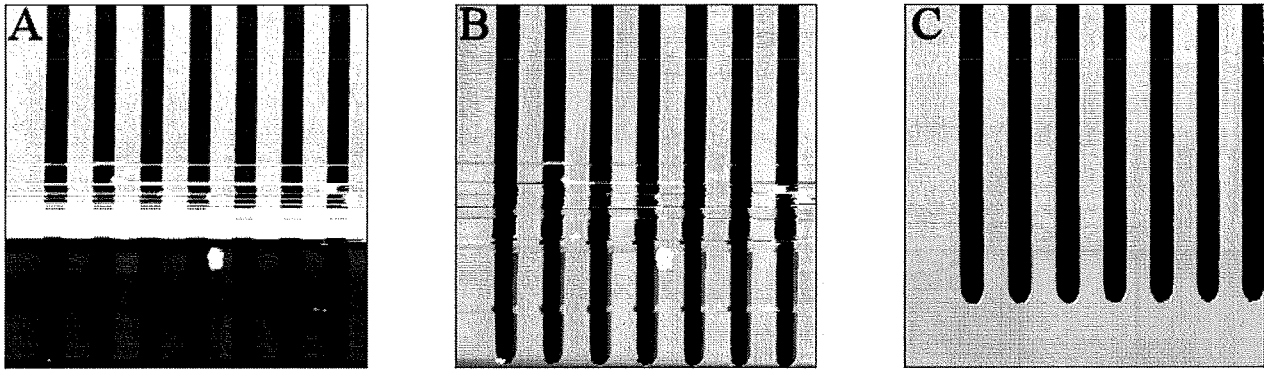
Figure 9. Height images of the same area of a 200 nm step grid before and after cleaning. A: Height image before cleaning, as captured. B: Flattened height image. C: Height image after cleaning, as captured. 15 μ m scans.

Bill Morris (6) of GE Corporate Research was perhaps the first to use CO₂ snow cleaning as an aid in cleaning AFM samples. He found that it removed particles and reduced the “nanoscum” on the surface. He said he got better images and fewer artifacts due to tip contamination. Previous demonstrations of imaging improvements before and after cleaning a given specimen were done using different spots. Here, to our knowledge, we show for the first time examination of the same spots on a single specimen. Fig. 9 shows images of a 2- μ m pitch calibration pattern before and after CO₂ cleaning. Each image was scanned starting at the top of the frame and proceeding downward. The upper portion of panel A shows smooth flat areas and straight grooves, whereas the lower portion shows numerous horizontal streaks associated with vertical steps (different colors). Even after flattening (panel B), the image was still corrupted by horizontal streaks and shifts in the groove edges. Horizontal and vertical shifts are due to material transfer to and from the probe tip during the scan. After replacing the contaminated probe and cleaning the specimen, we captured the height image shown in panel C. This image shows smooth flat areas and straight grooves throughout, without flattening.
